Artifacts in Architectural Study Collections as Seen from Different Points of View

The Old Merchant's House Ceiling Medallions

Residential Casement Windows

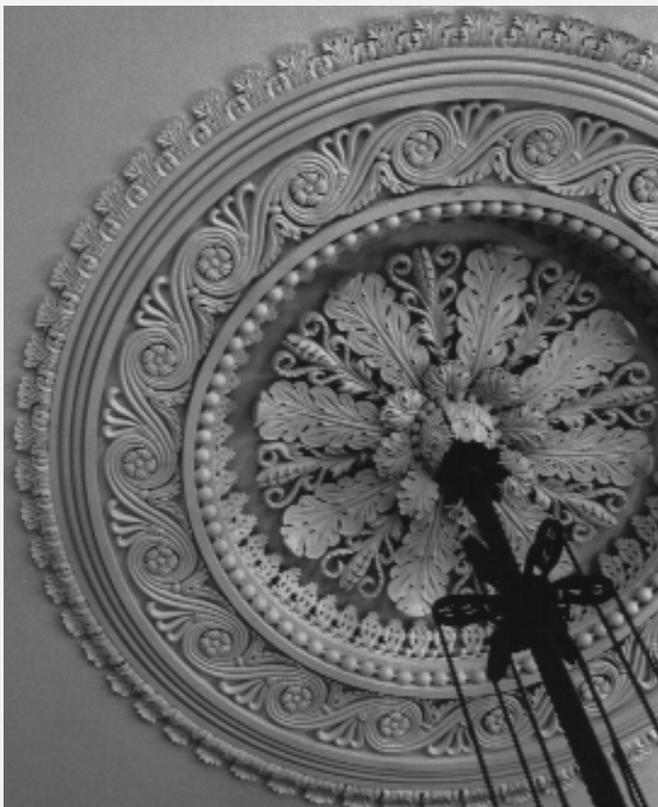
Fig. 1. Ceiling medallion repaired and reinstalled in the Old Merchant's House, New York, NY. Photo by the author.

The Old Merchant's House, c.1832, at 29 East Fourth Street in New York City, has been described as "transitional" to the extent that its unrestrained federal woodwork coexists handsomely with its robust Greek revival plaster ornamentation. Indeed, the matching ceiling medallions in the double parlors (see figure 1) are unquestionably the finest designs to survive into the late-20th century and are superior to any composed during the American classical revival.

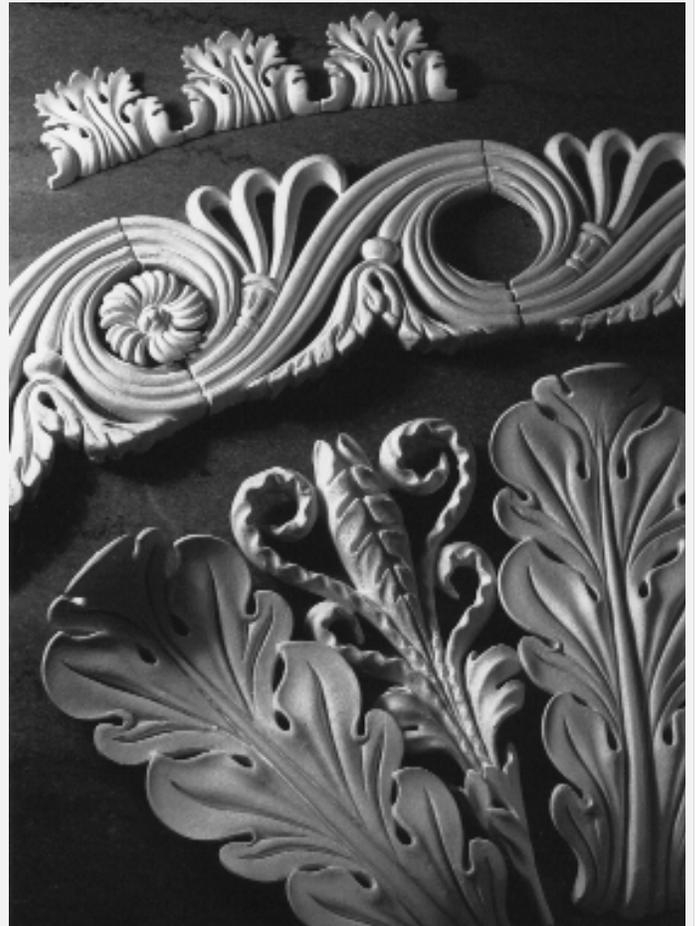
Fig. 2. These cast ornaments from a ceiling medallion in the Old Merchant's House, New York, NY, were removed to replicate missing originals. Historic plaster enrichments and the rubber molds that create them are a part of Mr. Flaharty's personal architectural study collection. Photo by the author.

With the flat plastering complete, the artisans turned plain-run, reeded surround mouldings on the ceilings by troweling a mixture of gypsum and lime ahead of revolving sheet metal template blade sections nailed to stocks and slippers. Off-site cast plaster enrichments, such as the illustrated center cluster, guilloche/rosette and surround acanthus foliage (see figure 2), were then set within and around the runs using plaster as an adhesive.

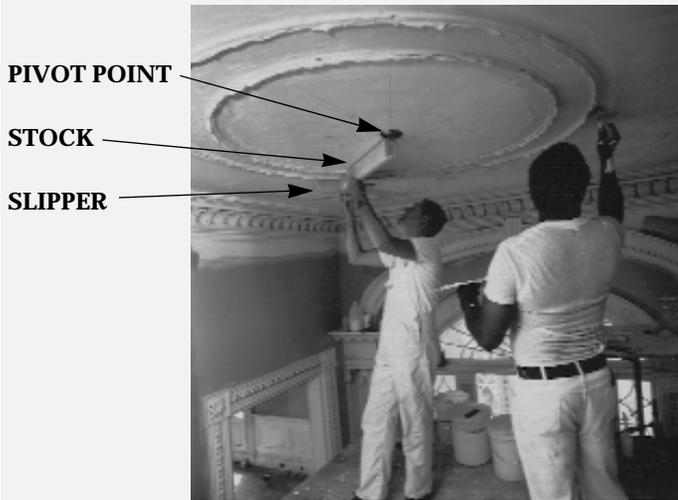
Fig. A. First, a plain-run surround is spun from a pivot point centered in the ceiling field. Photo by Peter Sanders.

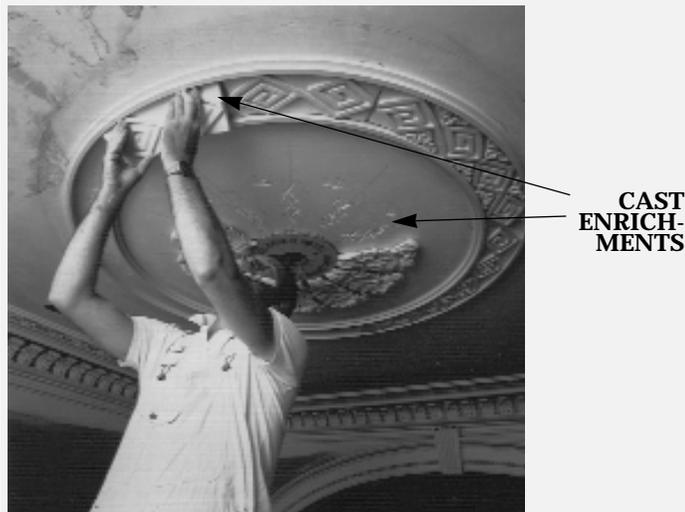
Fig. B. Ornament layout is determined using plane geometric principles; segmented locations are deeply scratched to provide a rough surface for adequate bonding using plaster as an adhesive. Photo by Peter Sanders.

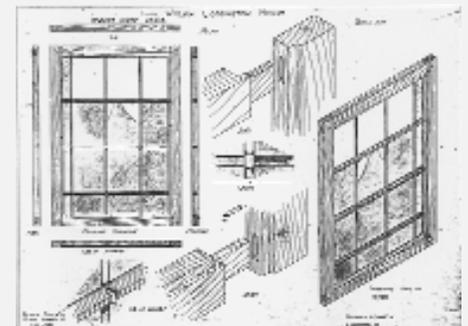
Fig. 1. Drawing made in 1929 of a c. 1641 wood casement window from the Governor William Coddington House, Newport, RI. The Rhode Island Historical Society's unsuccessful attempt to save the house from demolition in 1835 was one of the first concerted preservation efforts in the state. Both the sash and the drawing are now part of the study collection of the Rhode Island Historical Society, Providence, RI. Drawing courtesy Rhode Island Historical Society.

The wood casement sash depicted in the detailed drawing in figure 1 dates from c. 1641, and comes from the Newport, RI, home of Governor William Coddington. Now in the study collection of the Rhode Island Historical Society, Providence, the sash was the only feature salvaged when the Coddington house was demolished in 1835. Its survival, complete with glazing, affords a rare opportunity to examine the construction and design of a mid-17th-century architectural artifact.

The sash echoes the windows seen in the European towns and villages from which the colonists migrated. The simple mortise and tenon construction and the casement method of operation (side-hung sash that swing outward on hinges) are typical of the period, although stationary sash were also popular. The small size of the Coddington sash (27 1/2" H. x 20 1/2" W. x 1" D.) is characteristic of 17th-century American windows and reflects the scarcity and high cost of window glass, as well as the need for protection against harsh North American winters.

Glazing consists of small, hand-blown panes, set into the sash with lead strips termed "comes" or "calmes," reinforced with thin wooden bars. Although a rectangular pane is used here, diamond-shaped glazing was also common. Despite attempts at window glass manufacture at Jamestown, VA, most early glazing had to be imported from
